**Site:** Detroit Windshield Survey (1539 E Grand Blvd)

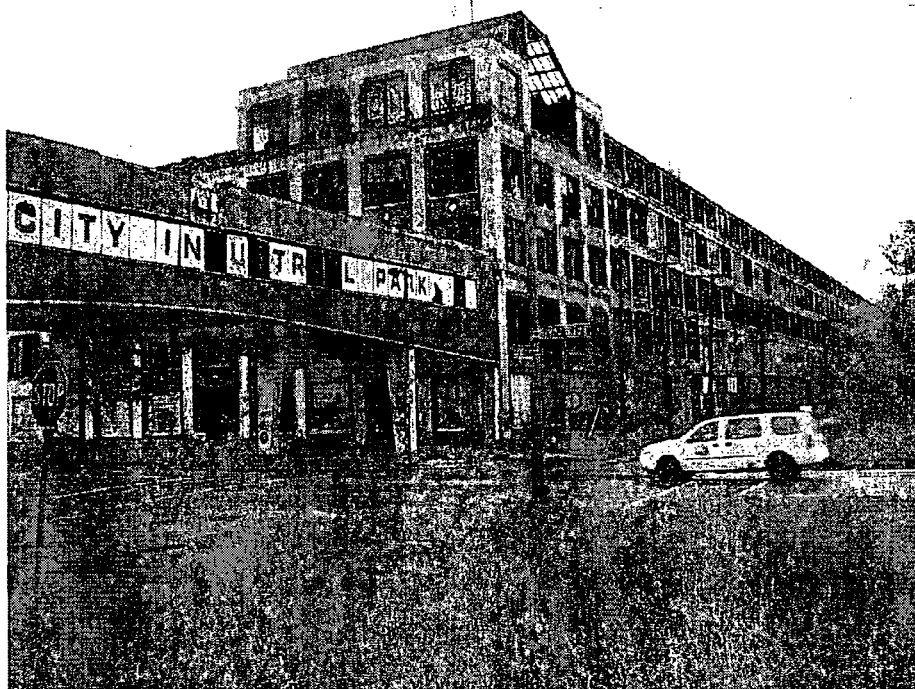
**Photograph No.:** 1

**Subject:** East building frontage (North Series) along E Grand Blvd and Concord Street.

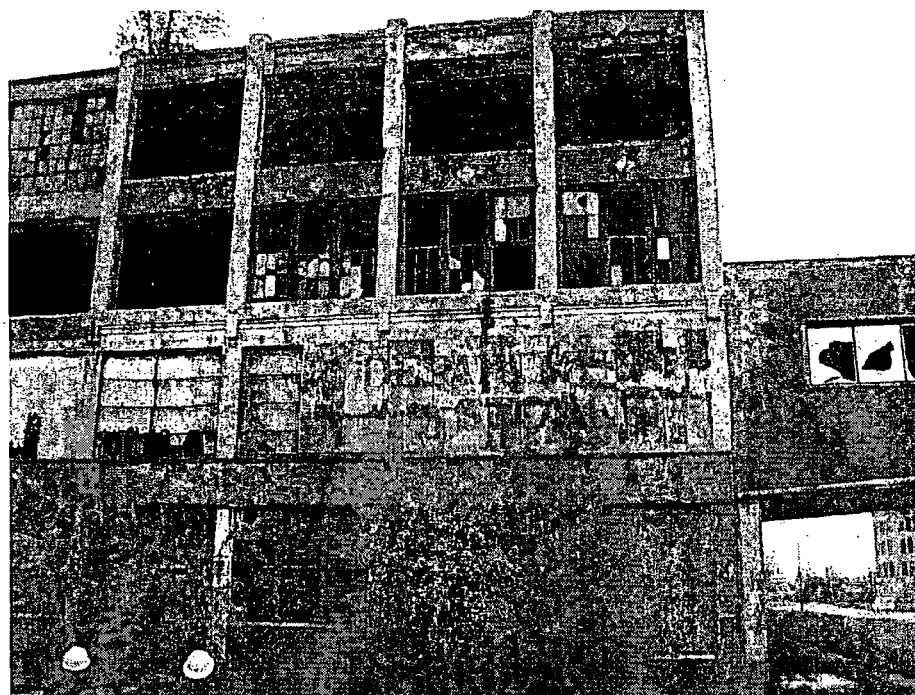
**Photograph No.:** 2

**Subject:** East building frontage (Middle Series) at the corner of E Grand Blvd and Concord Street.

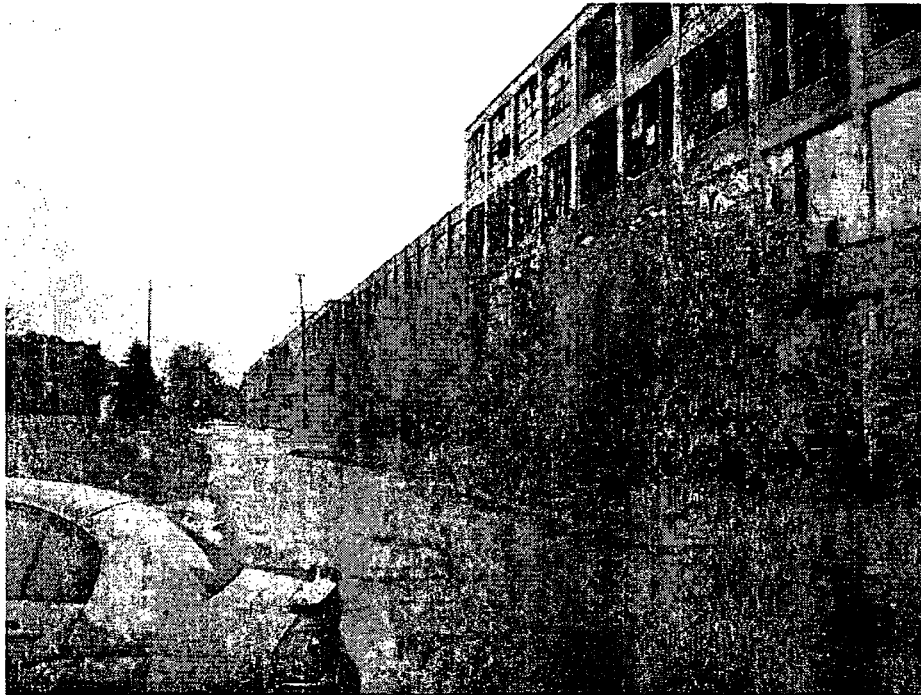
**Photograph No.:** 3

**Subject:** East building frontage (Middle Series and South Series) along Concord Street.

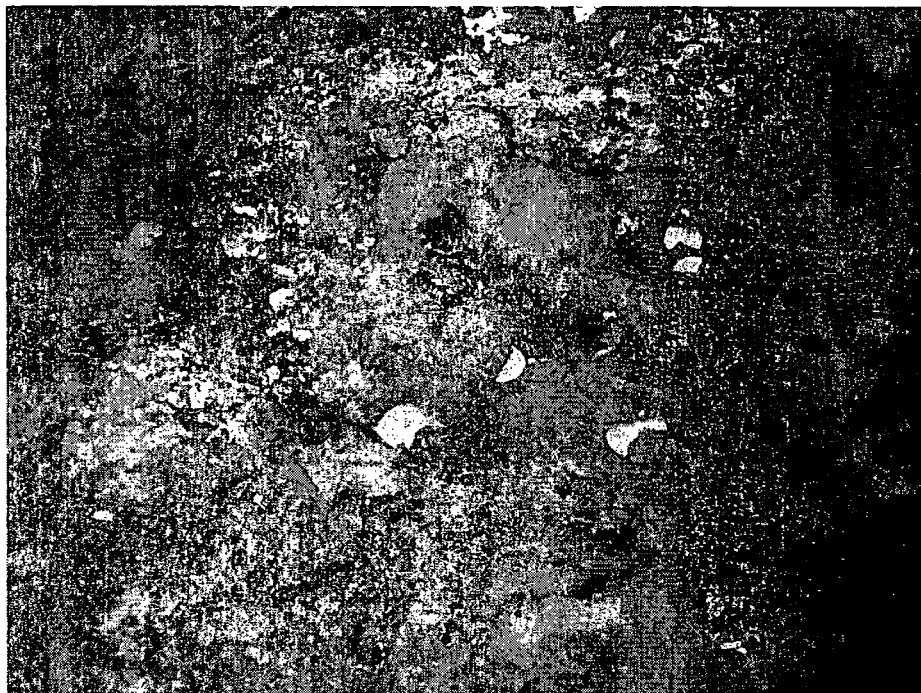
**Photograph No.:** 4

**Subject:** Pile of trash and deteriorated building materials in a Middle Series building.

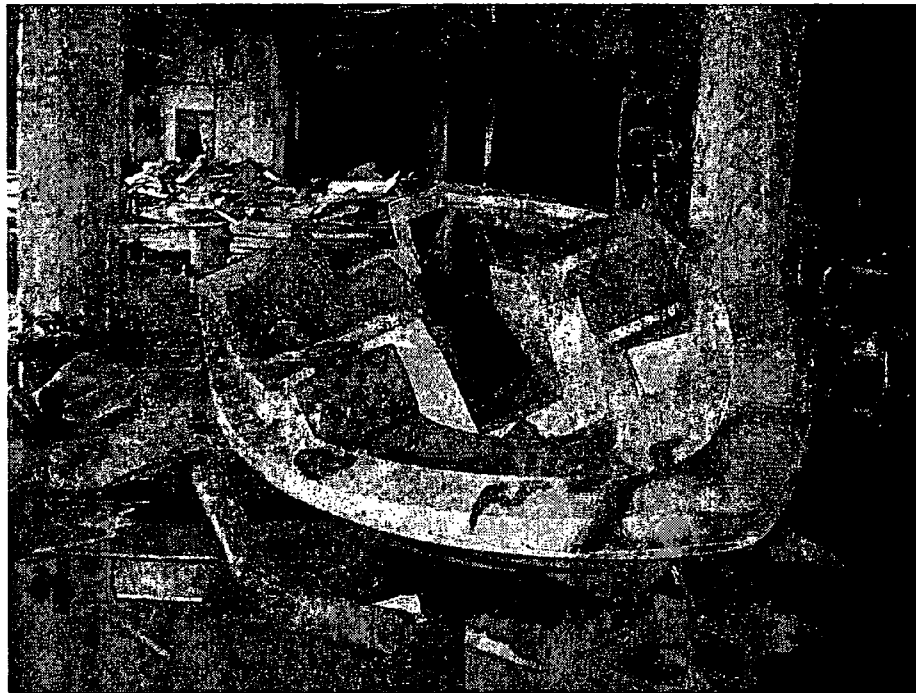
**Photograph No.:** 6

**Subject:** Boat and other trash and bulk debris in a Middle Series building.

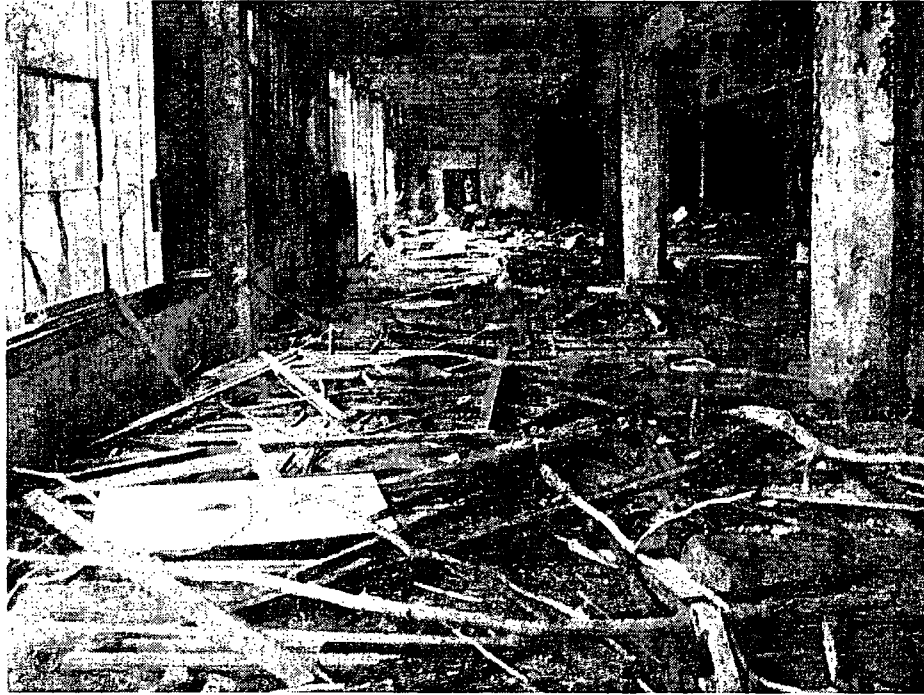
**Photograph No.:** 7

**Subject:** Trash and bulk debris in a North Series building.

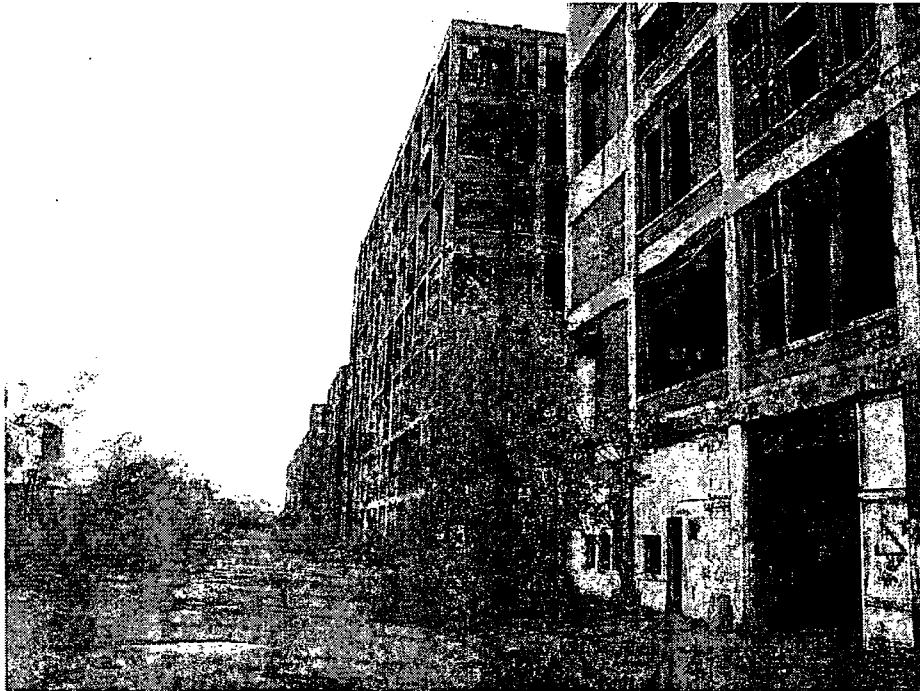
**Photograph No.:** 8

**Subject:** West building frontage (North Series) along an unnamed alley.

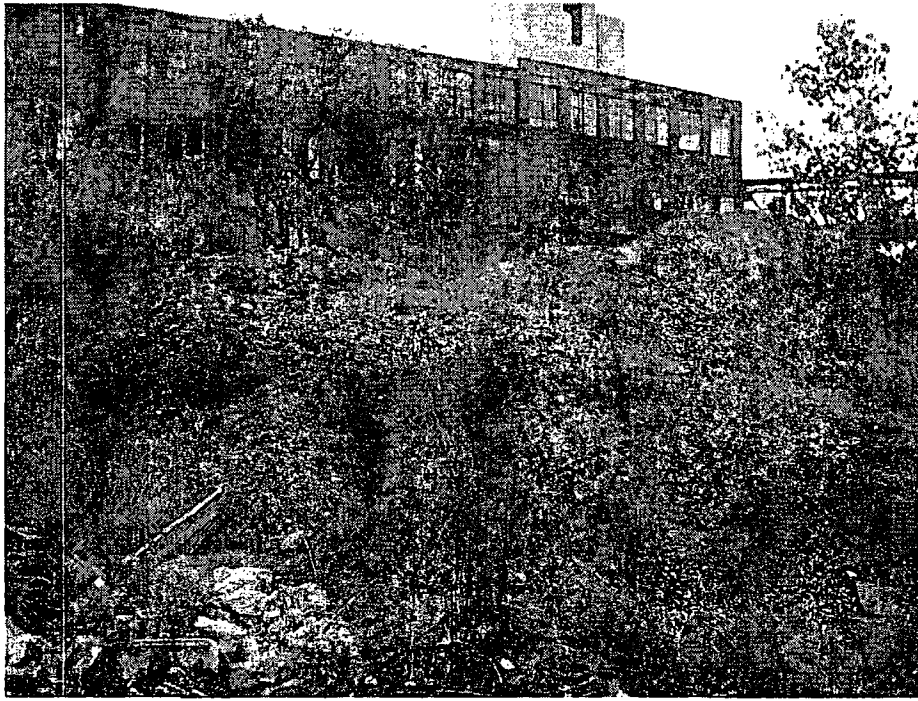
**Photograph No.:** 9

**Subject:** Piles of dirt and crushed building materials west of the North Series buildings.

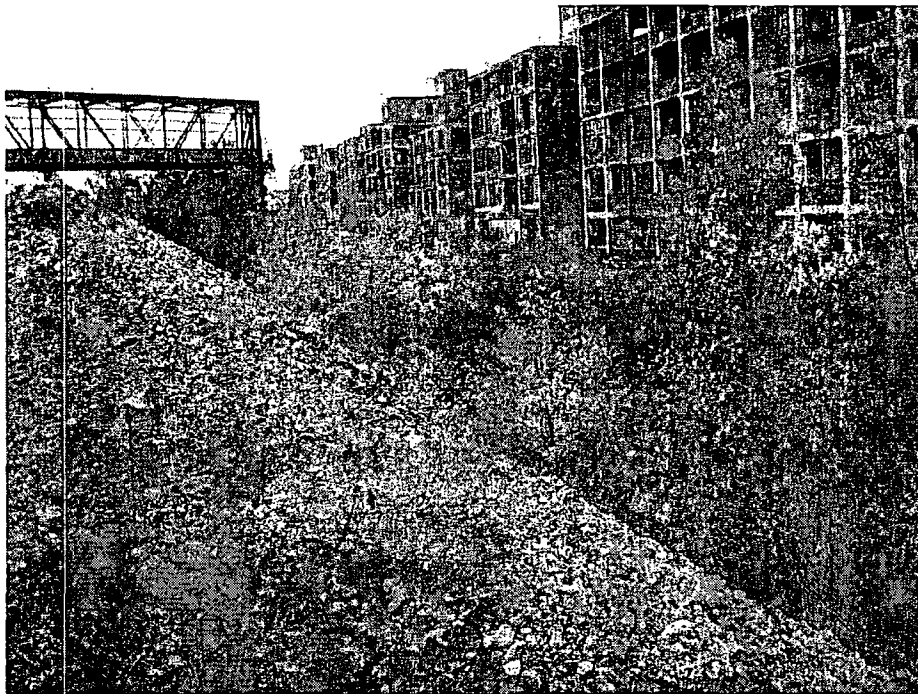
**Photograph No.:** 10

**Subject:** Piles of dirt and crushed building materials west of an exposed basement and the North Series buildings.

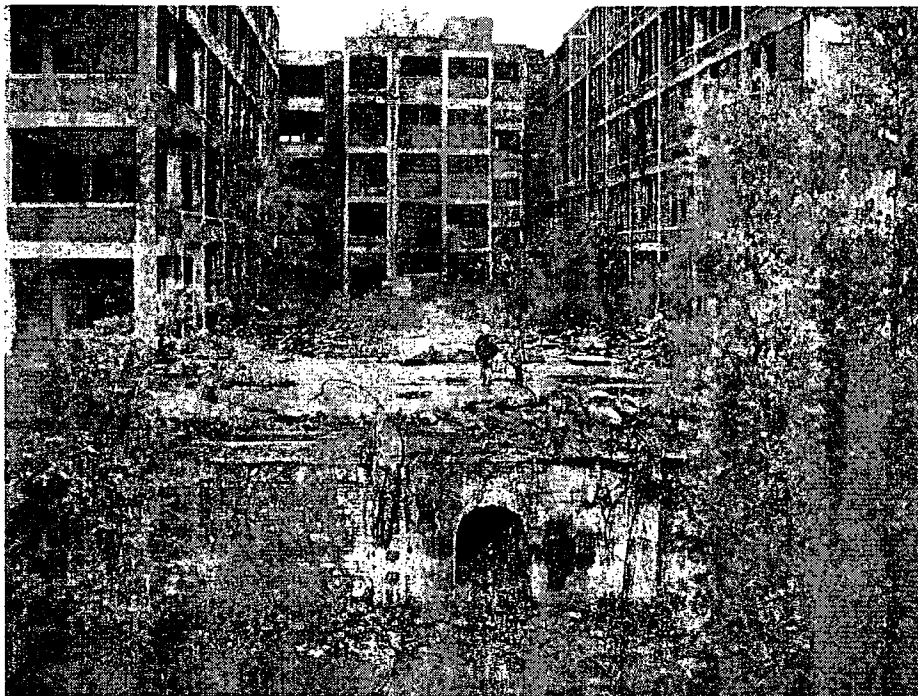
**Photograph No.:** 11

**Subject:** Utility tunnel entrance from the exposed basement west of the North Series buildings.

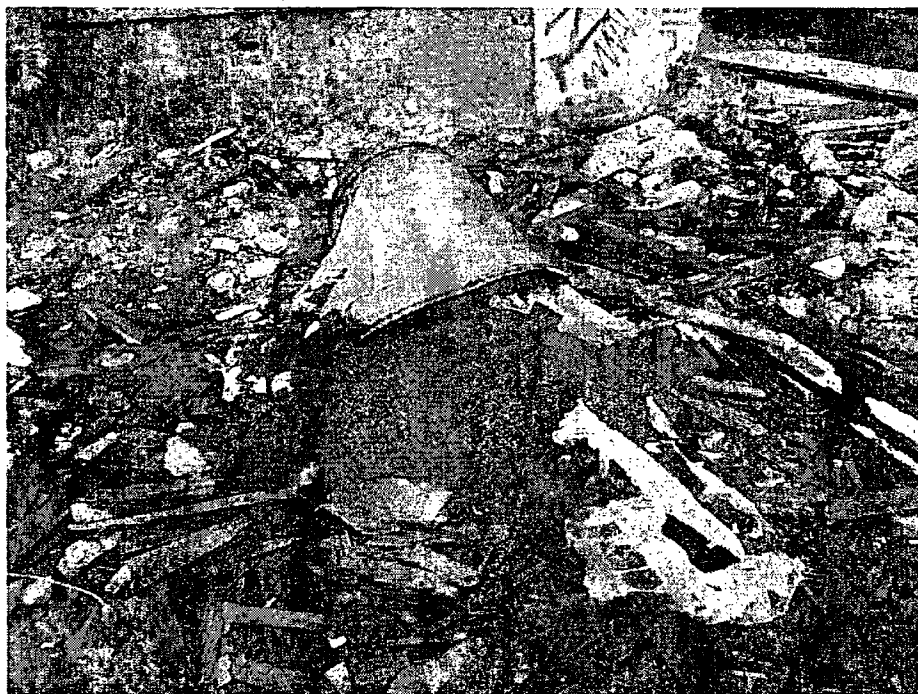
**Photograph No.:** 12

**Subject:** Spilled material from a 55-gallon fiber drum west of the North Series buildings.

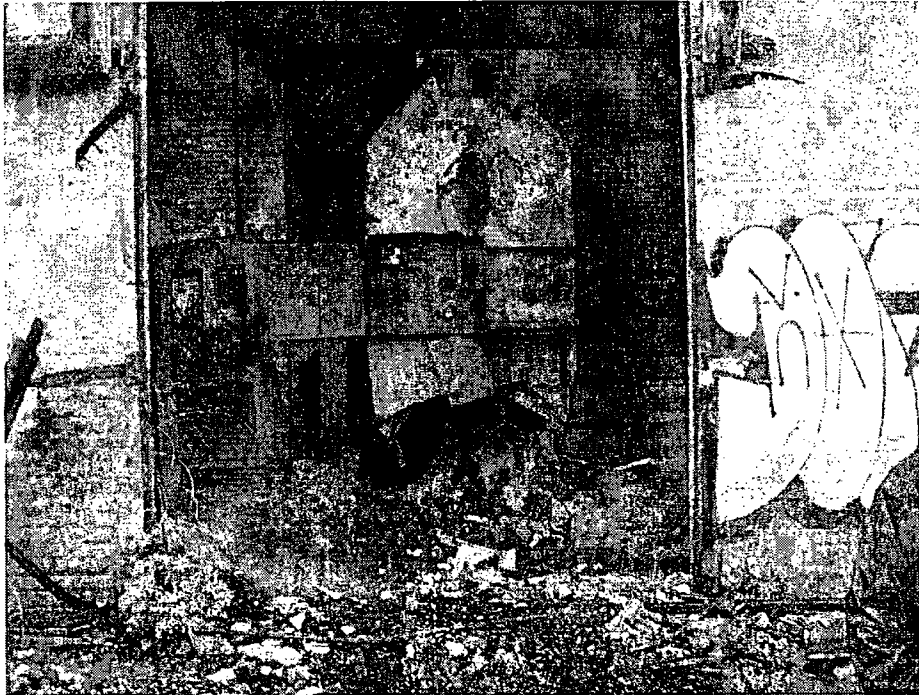
**Photograph No.:** 13

**Subject:** Pile of ash near an old furnace along the west side of a North Series building.

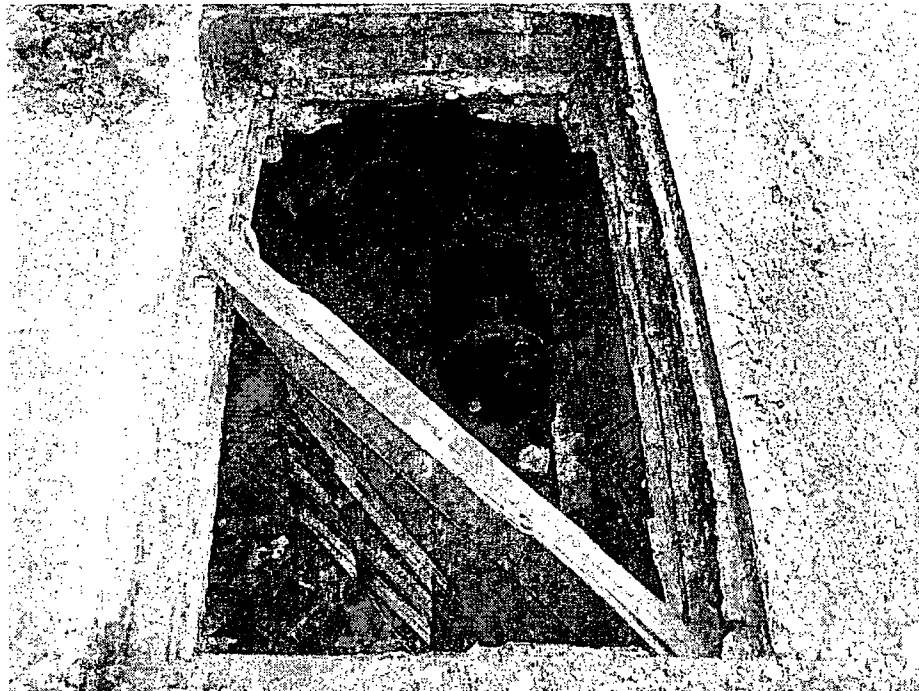
**Photograph No.:** 14

**Subject:** Drum and pile of unknown material in a utility tunnel west of the North Series buildings.

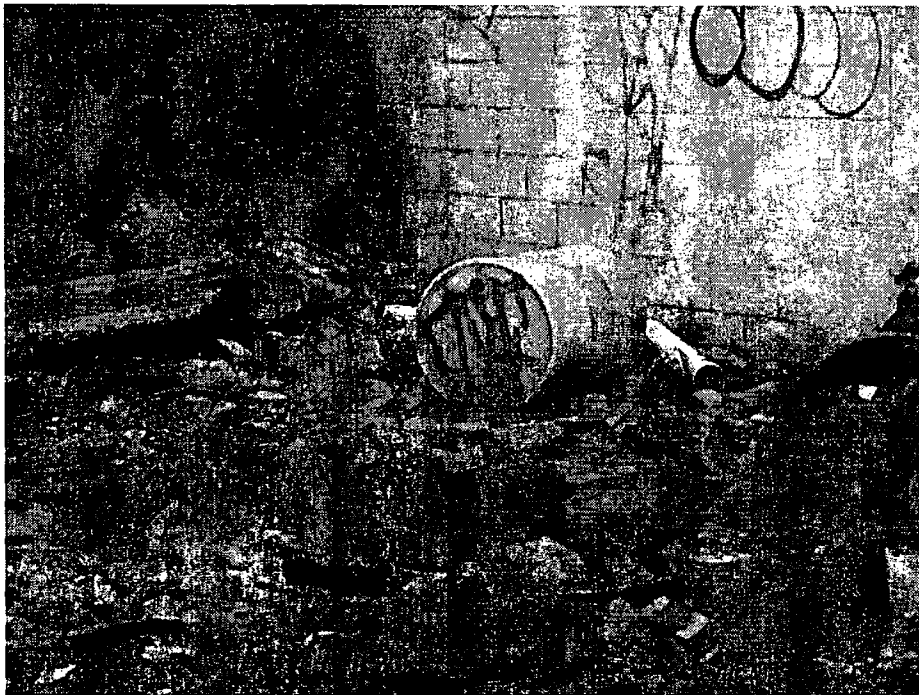
**Photograph No.:** 15

**Subject:** Drum with unknown liquid contents along the west side of a North Series building.

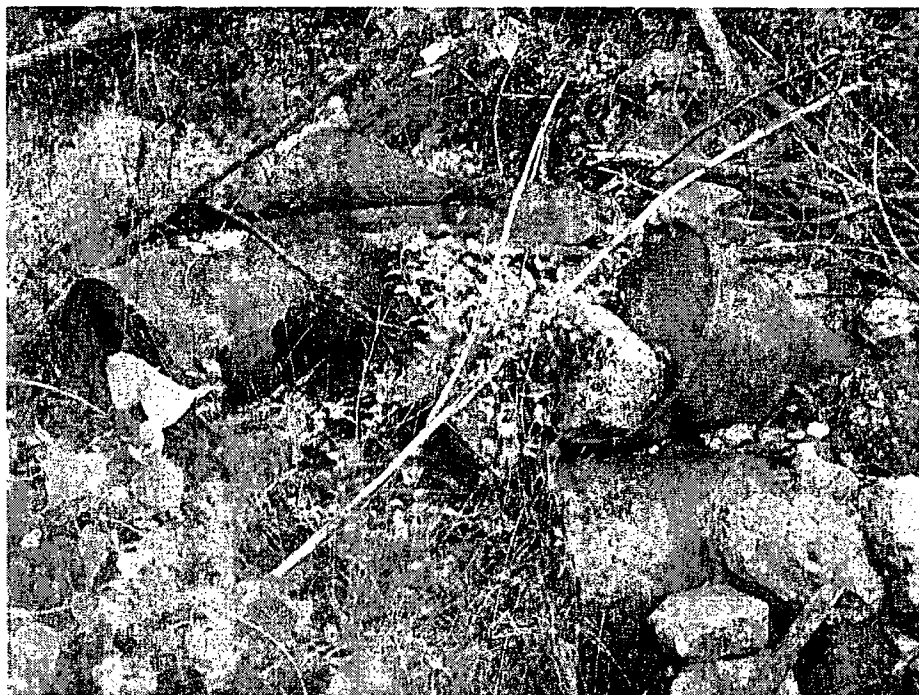
**Photograph No.:** 7

**Subject:** Partially buried drums in the northwest corner of the property.
